GEOLOGICAL AND GEOTECHNICAL FACTORS RESPONSIBLE FOR LANDSLIDE  
SUSCEPTIBILITY OF THE KOPE FORMATION IN CINCINNATI, OHIO

A thesis submitted  
To Kent State University in partial  
Fulfillment of the requirements for the  
Degree of Masters of Science

by  
Michael P. Glassmeyer

December, 2014

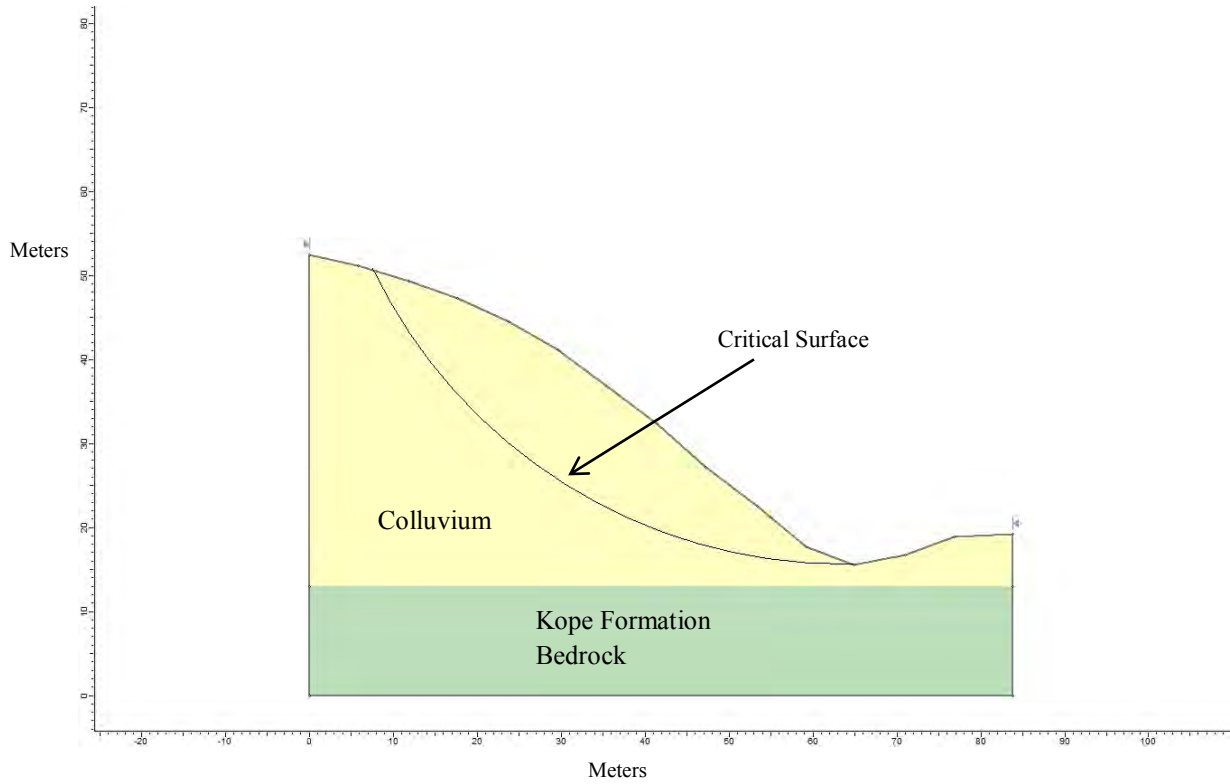
The results of the stability analysis show that the cohesion of the soil would need to be 61.2 Kpa (1287 lb/ft<sup>2</sup>), instead of 27.5 Kpa (575 lb/ft<sup>2</sup>) for the landslide site at the

Figure 5.2: Critical surface for the minimum factor of safety for dry and saturated conditions for the Ten Mile Road landslide as determined by the Slide program.

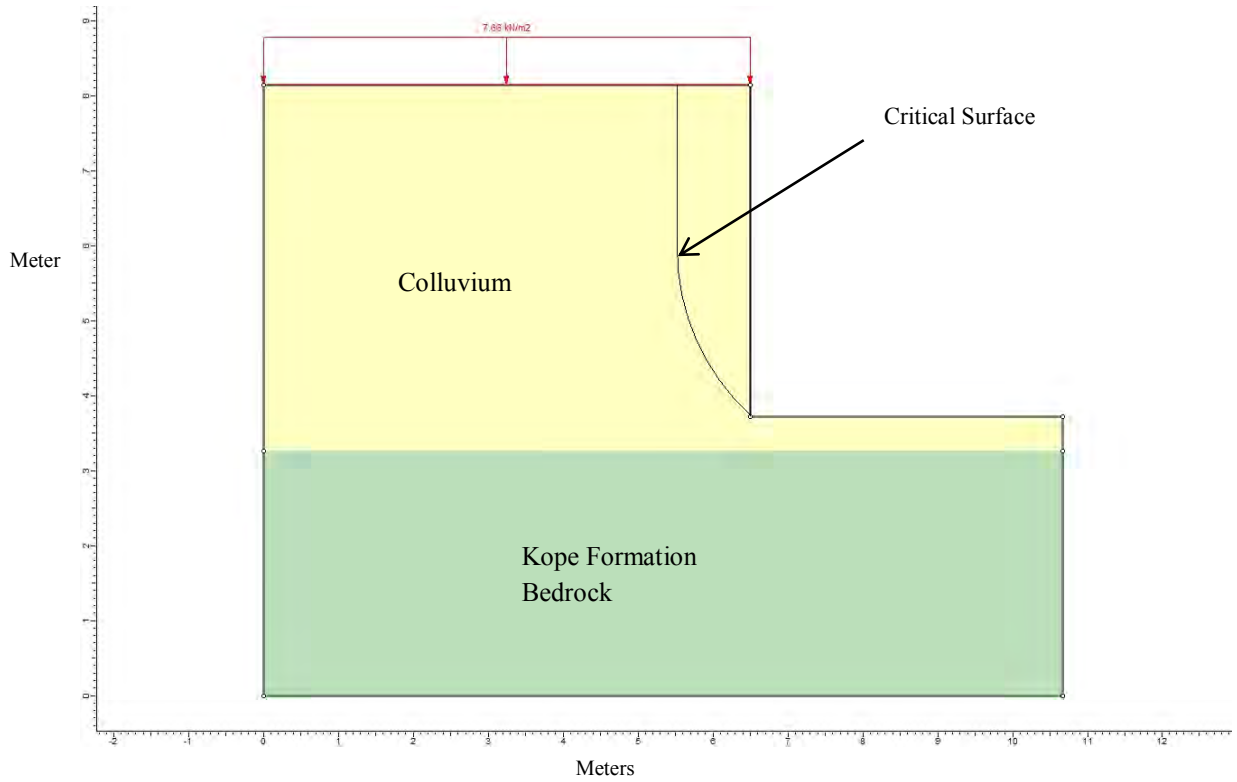
Figure 5.3: Critical Surface for the minimum factor of safety for wet and dry conditions for the Wagner Road landslide as determined by the Slide program.

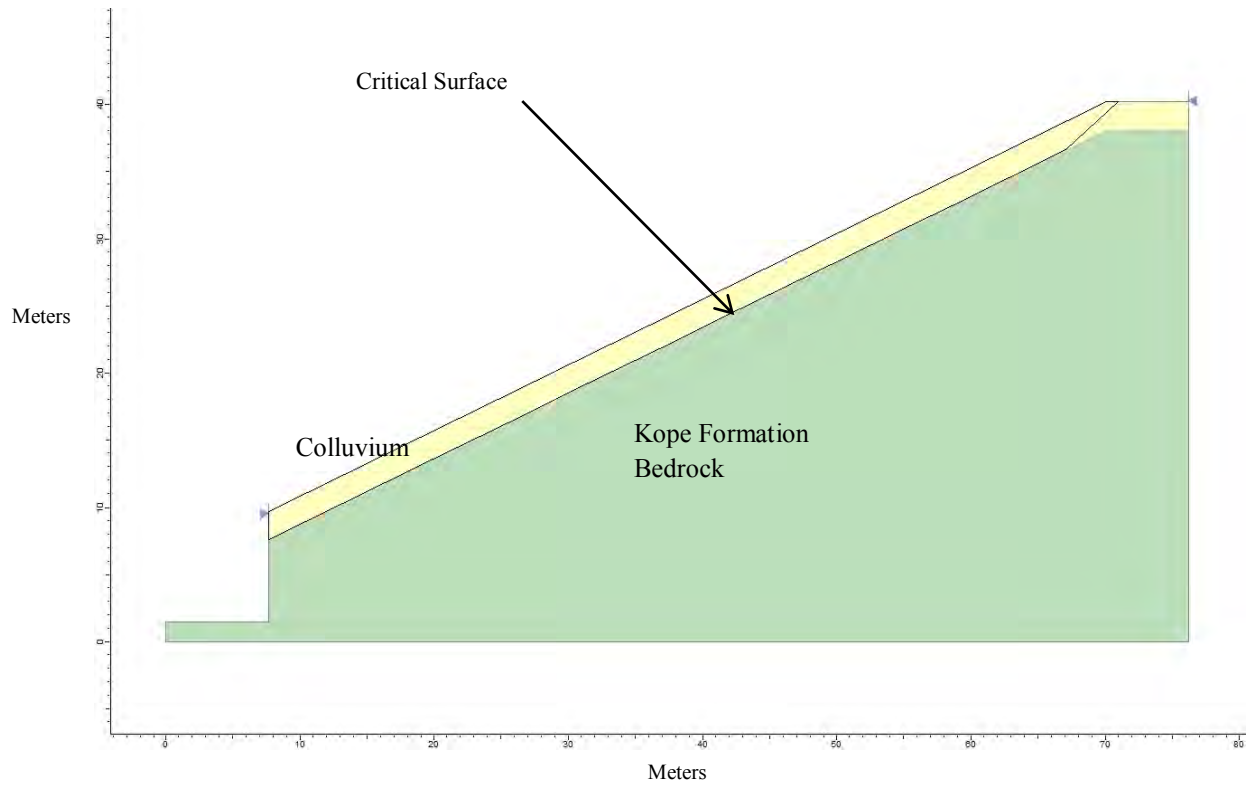
A stability analysis was performed on the Columbia Parkway landslide using the Slide program. The critical surface as determined by the Slide program is located along the contact between the colluvial soil and the underlying bedrock. The critical surface initiates at the top of the slope and progresses along the contact and emerges at the top of

The minimum factor of safety for the dry condition is 1.04, when the colluvium is at its natural water content, the factor of safety is 0.95, and when the colluvium is saturated the factor of safety is 0.94. If the water table is located in the middle of the colluvium, 1 m (3.3 ft) below the ground surface, the factor of safety is reduced to 0.77 and if the water table is located at the ground surface the factor of safety is reduced to 0.68. The results of the stability analysis show that the soil-rock friction angle need to be  $18^\circ$  instead of  $15^\circ$  (Table 4.5) to have a factor of safety equal to 1, if the cohesion remains constant (6.8 Kpa (142 lb/ft<sup>2</sup>)). The stability analysis also shows that the slope would need to have cohesion equal to 8.9 Kpa (185 lb/ft<sup>2</sup>) for the slope to have a factor of safety equal to 1 if the friction angle remains constant ( $15^\circ$ ).

Figure 5.4: Critical Surface for the minimum factor of safety for wet and dry conditions as determined by the Slide program for the Columbia Parkway landslide.

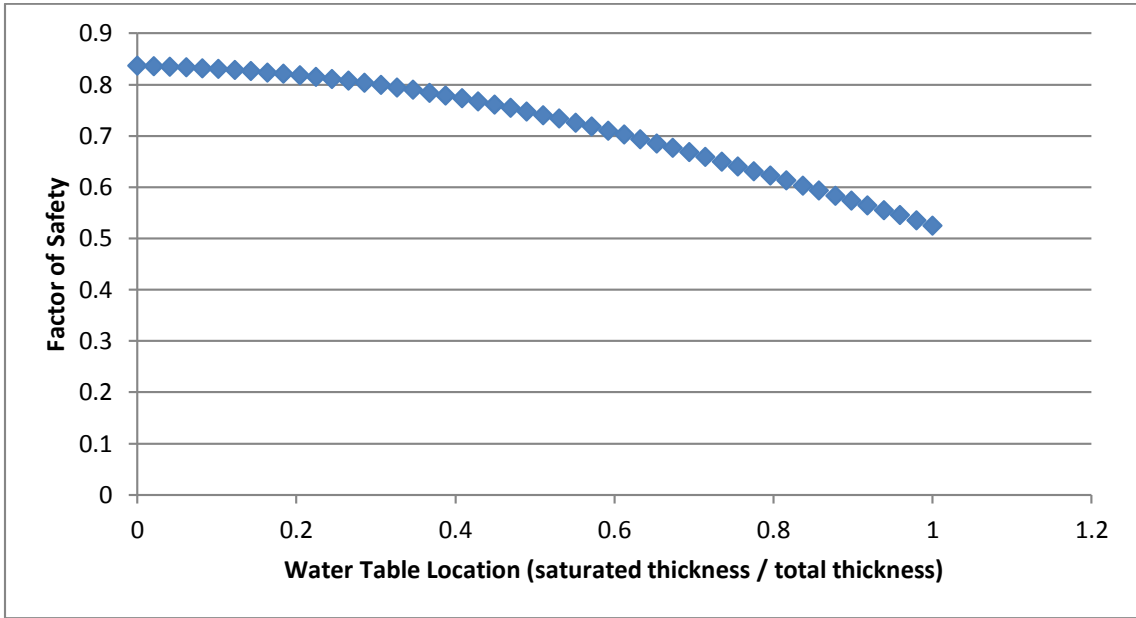
The presence of groundwater in many of the slopes is evident from the continually flowing water or water seeps that can be observed throughout the year. Water seeps were frequently observed in the scarp areas of the landslides investigated in this study. Thus, development of pore pressure is another important factor that explains

Figure 6.7: Relationship between water table location and factor of safety for the Ten Mile Road landslide, 1 indicates the water table is just below the ground surface and 0 represents the water table being located on the bedrock.

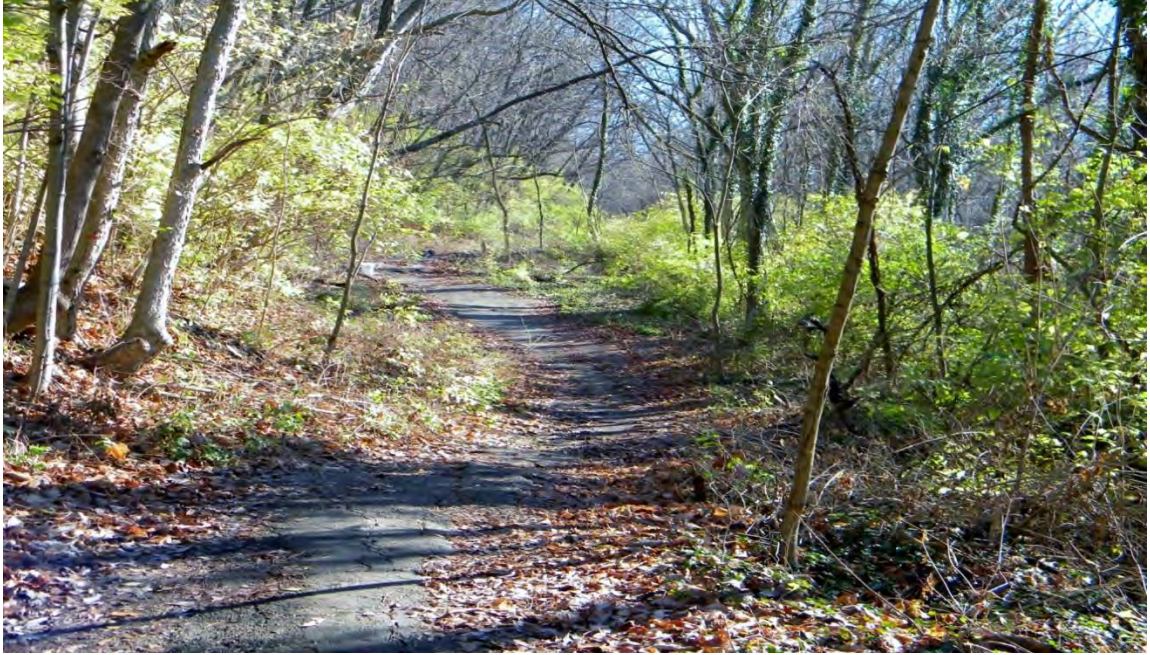
The series of failures that comprise the Delhi Pike landslide complex are caused by a combination of factors including the low strength properties of the soil, over steepening of slope during the construction of the Delhi Pike, poor drainage, and the addition of weight to the slope from the road and the houses.

Figure AV.7: Damage caused to Delhi Pike by the landslide.

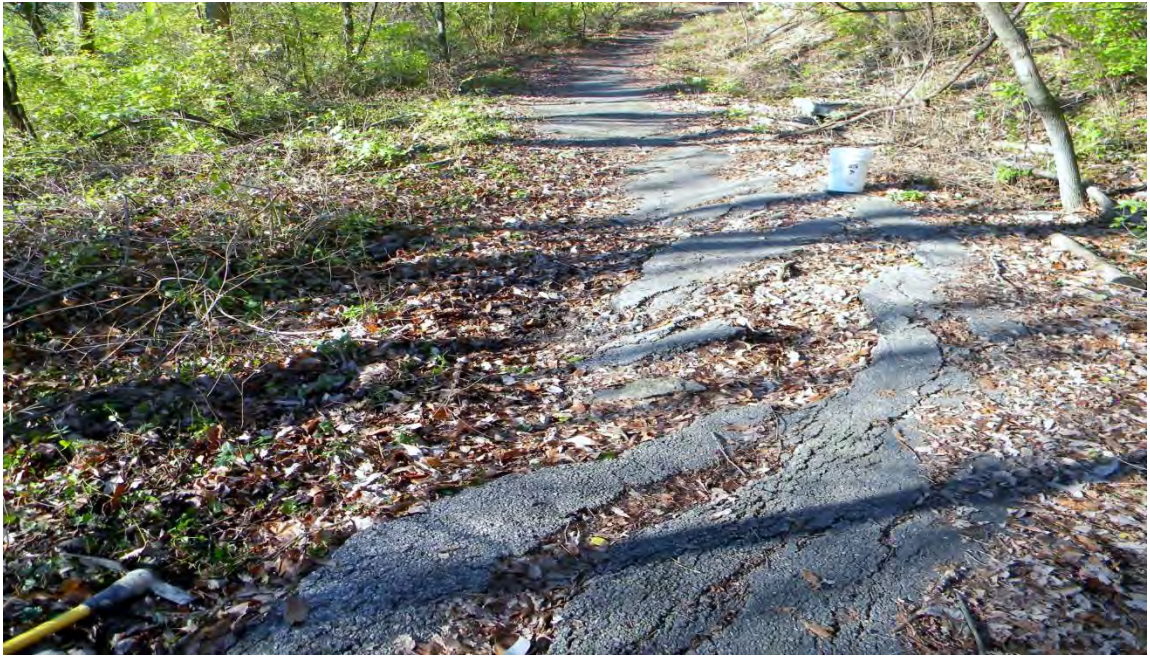
Figure AV.8: Scarp face of one of the landslides at the Delhi Pike landslide complex site.

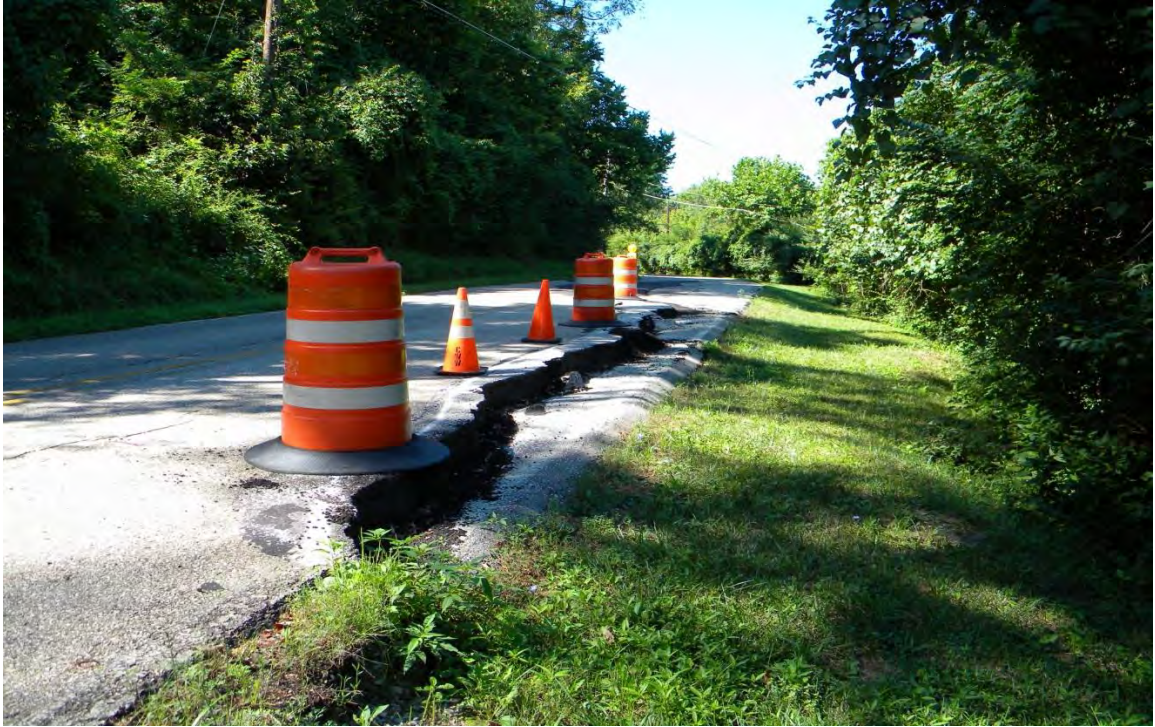
A combination of low residual shear strength, addition of weight on top of slope, and undercutting of the slope toe by the stream appears to be have contributed to the continual landslide problem along Elstun Road.

Figure AV.11: An example of the damage caused to Elstun Road as a result of landsliding.

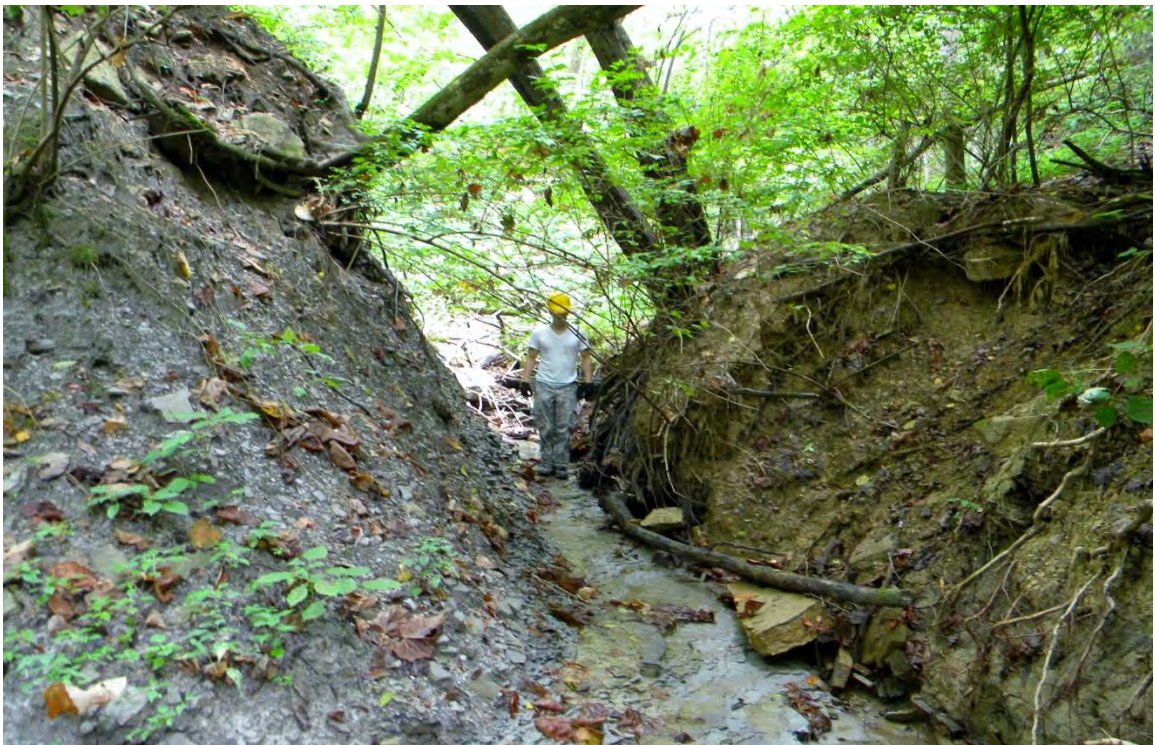
Figure AV.12: The landslide toe (on right) of the Elstun Road landslide.

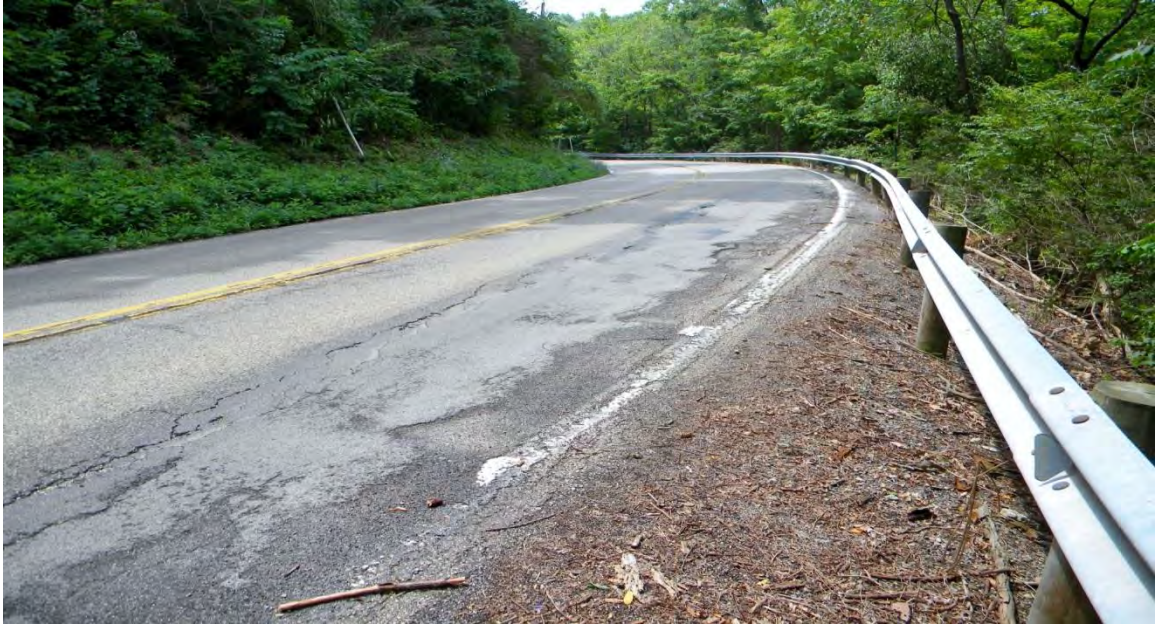
The Nordyke Road landslide is the combined effect of low shear strength of the soil, the undercutting of the toe by the stream, and pore pressure buildup.

Figure AV.14: Damage caused to Nordyke Road by landslide activity.

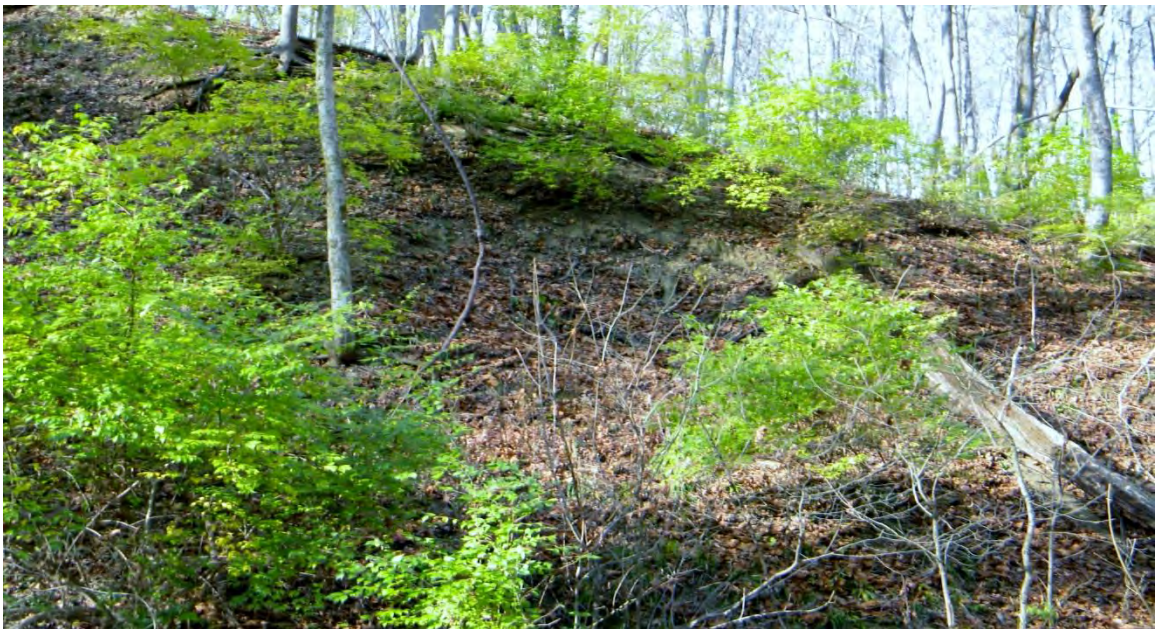
Figure AV.15: Head scarp of the Nordyke Road landslide.
