GEOLOGICAL AND GEOTECHNICAL FACTORS RESPONSIBLE FOR LANDSLIDE  
SUSCEPTIBILITY OF THE KOPE FORMATION IN CINCINNATI, OHIO

A thesis submitted  
To Kent State University in partial  
Fulfillment of the requirements for the  
Degree of Masters of Science

by  
Michael P. Glassmeyer

December, 2014

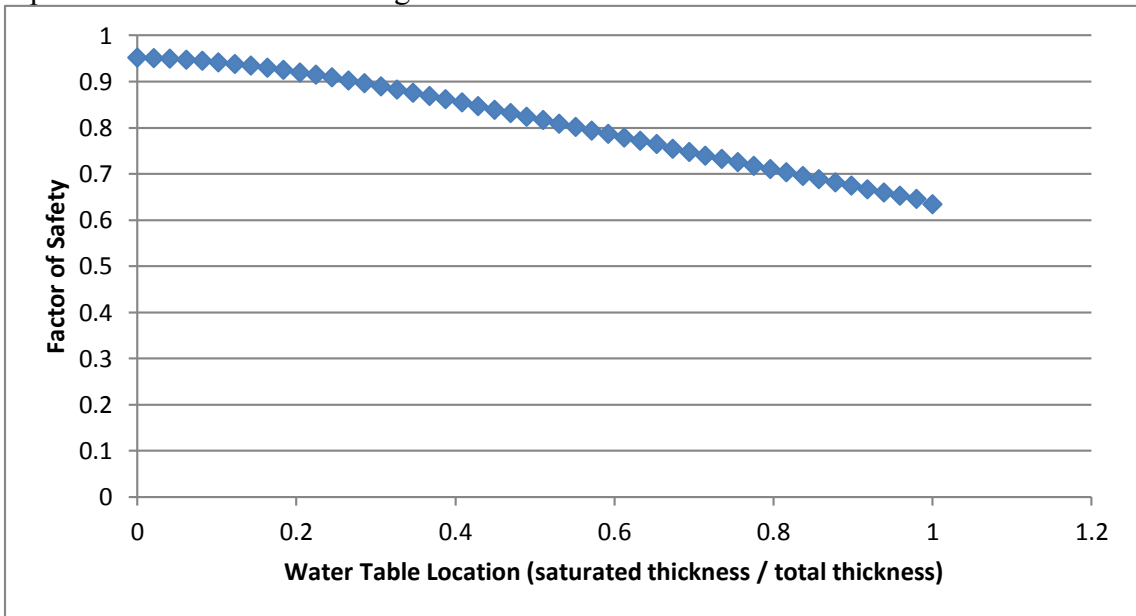
The plots in Figures 6.7 through 6.9 and the results of the stability analysis (Chapter 5) show that as the water table within the slope rises the factor of safety of the slope gradually begins to decrease. The factor of safety is at its lowest point when the water table is just below the ground surface. When the water table is just below the ground surface, i.e. the soil is saturated, the factor of safety for the slope decreases by approximately 1/3 of its original. However, only partial saturation of the slope is required to cause failure as the slopes already have a factor of safety below 1.

Figure 6.8: Relationship between water table location and factor of safety for the Wagner Road landslide, 1 indicates the water table is just below the ground surface and 0 represents the water table being located on the bedrock.

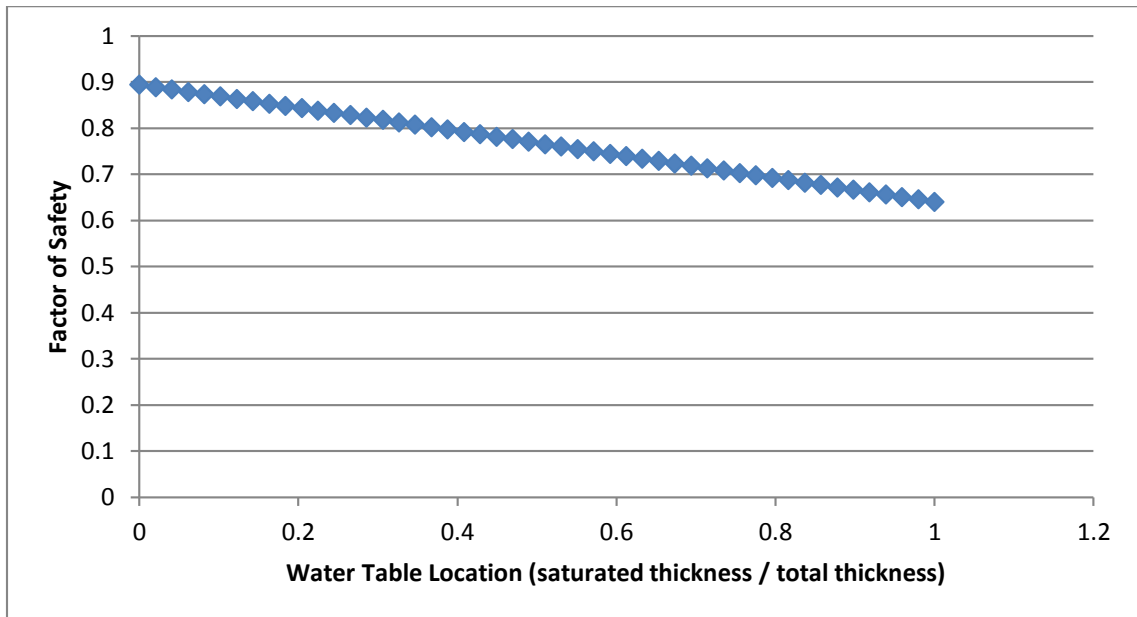
Figure 6.9: Relationship between water table location and factor of safety for the Columbia Parkway landslide, 1 indicates the water table is just below the ground surface and 0 represents the water table being located on the bedrock.

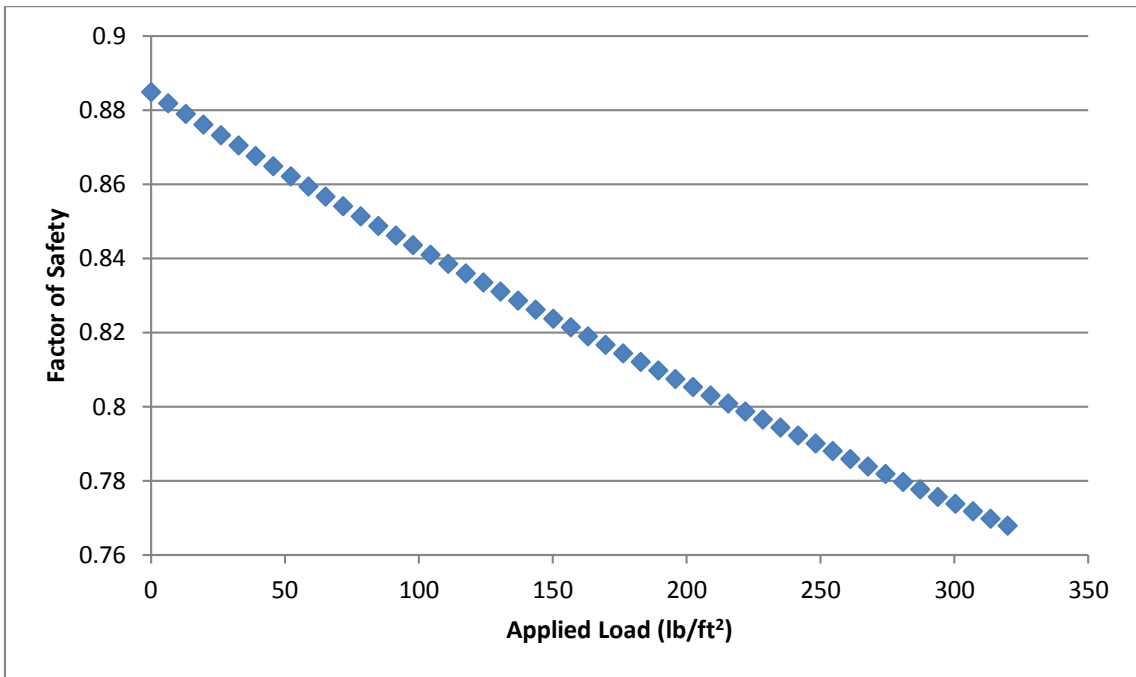
Human activity is an important factor in the stability of many slopes in the Cincinnati area. Construction activities alter the stability of a slope in two ways: (i) by adding weight to the top of the slope, and (ii) by removing lateral support the toe of the slope. Figure 6.10 shows the relationship between the load applied to the top of the slope and the factor of safety for the Wagner Road landslide.

Figure 6.10: Relationship between load applied to the top of the slope and factor of safety for the Wagner Road landslide.

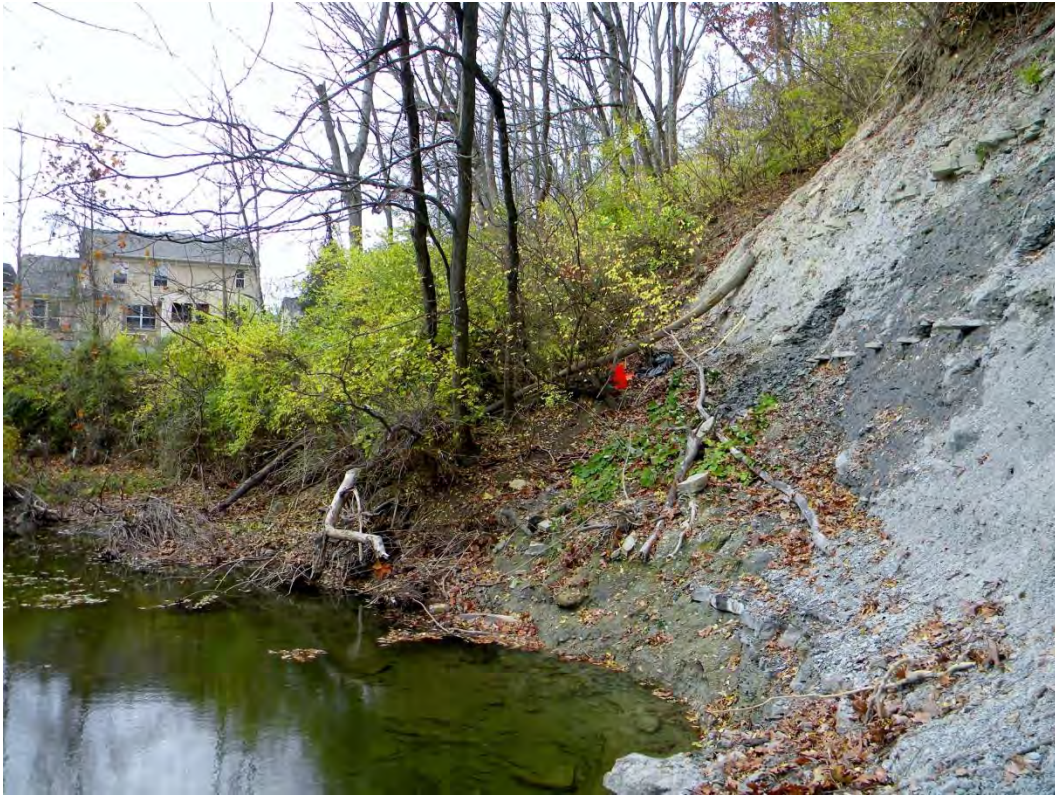
Many slopes in the Cincinnati area are subject to erosion of the slope toe by a stream. The erosion of the toe removes the lateral support, reducing the resisting forces. Thus, undercutting of the slope toe, facilitated by the low durability of the Kope Formation is a very important factor responsible for the high susceptibility of the Kope Formation to landsliding. Figure 6.11 shows a small stream removing material from the base of a slope by undercutting the toe at the Berkshire Road landslide..

Figure 6.11: Undercutting the toe of the slope at the Berkshire Road landslide.

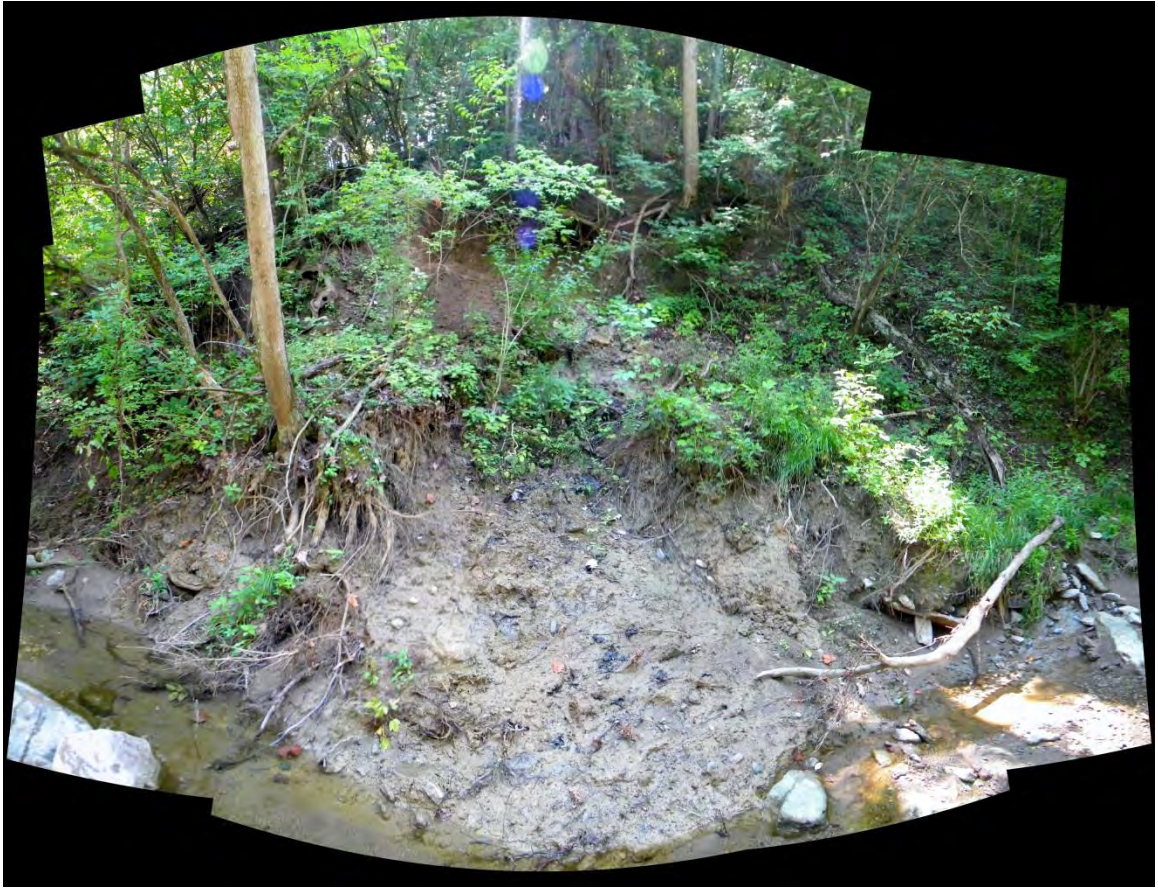
The Eight Mile Road landslide is located 16 km (10 miles) east of downtown Cincinnati. The failure occurred on the western side of Eight Mile Road approximately 0.8 km (0.5 miles) south of its intersection with the Bridle Road and 8 Mile Road (Figure AV.1). This landslide was identified from LiDAR derived maps as well as aerial photographs as can be seen in Appendix VI. The hillside at this site is 30 m (98 ft) high and prior to failure had a slope angle of 30°. The landslide is 26 m (85 ft) long, 39 m (127 ft) wide, and has a 3.7 m (12 ft) of displacement along the scarp. The toe of the landslide is located along the bank of a small stream (Figure AV.2).

The probable cause of the Eight Mile Road landslide is the low shear strength of the soil and the development of pore water pressure within the hillside. The initial slope angle of the hillside is too steep for the slope to remain stable given the low strength parameters and buildup of pore pressure. Undercutting of the slope toe by the stream also appears to have contributed to the failure.

Figure AV.2: View of the toe of the Eight Mile Road landslide.

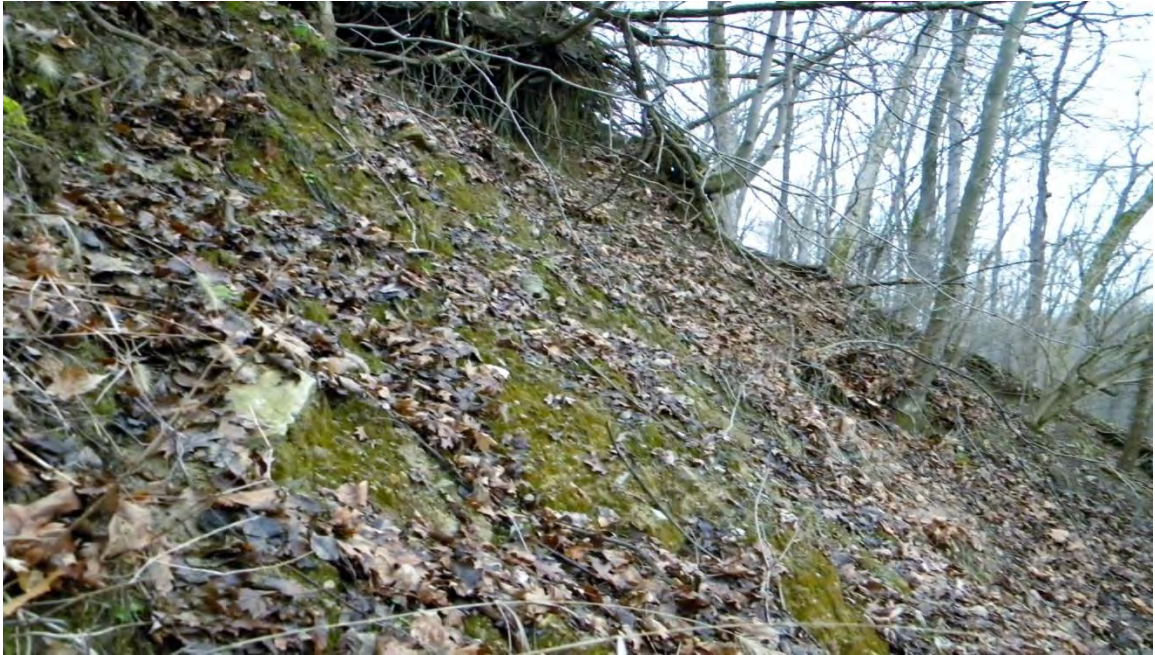
Similar to the Eight Mile Road landslide, low shear strength parameters, buildup of pore pressure, and undercutting of the toe by the stream water appear to be the probably causes of landslide at the Ten Mile Road site.

Figure AV.4: The scarp face of the Ten Mile Road Landslide.

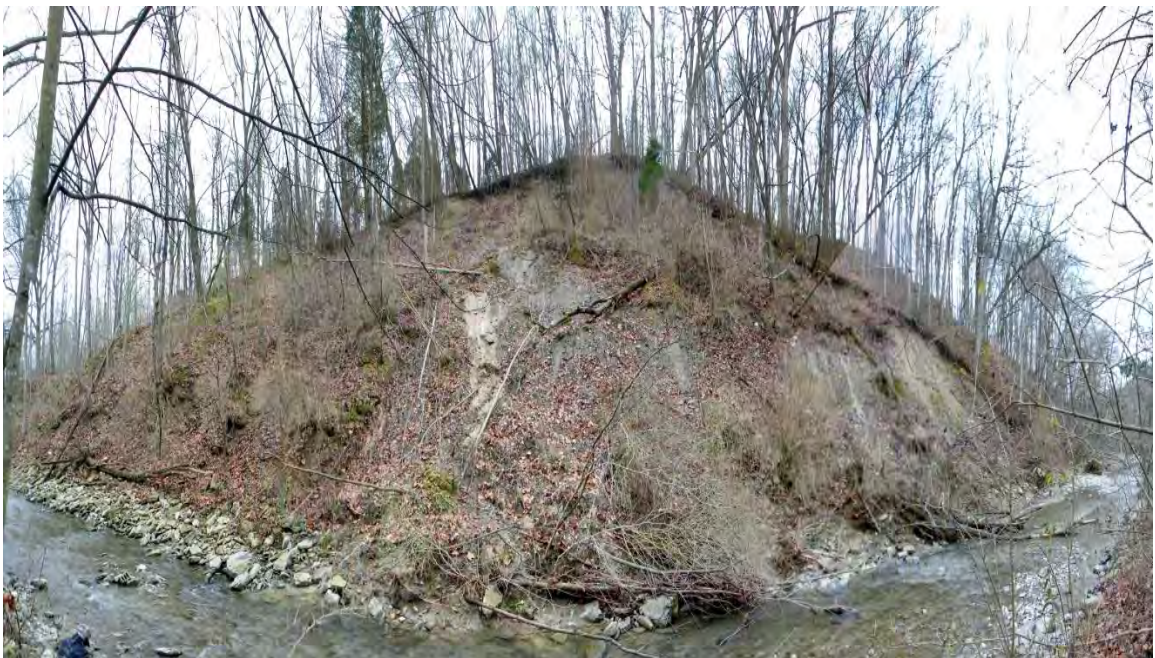
The Ten Mile Road landslide is located 24 km (15 miles) east of downtown Cincinnati. The failure occurred on the eastern side of Ten Mile Road approximately 100 m (330 ft) north of the intersection of Pond Run Road and Ten Mile Road (Figure AV.3). This slope failure was identified from LiDAR derived maps Appendix VI. The landslide is 43 m (141 ft) long, and 13 m (45 ft) wide. The scarp face is 3 m (10 ft) high (Figure AV.4). The toe of the landslide is located along the bank of a small stream (Figure AV.5).

Figure AV.5: The toe of the Ten Mile Road landslide, undercut by a stream.

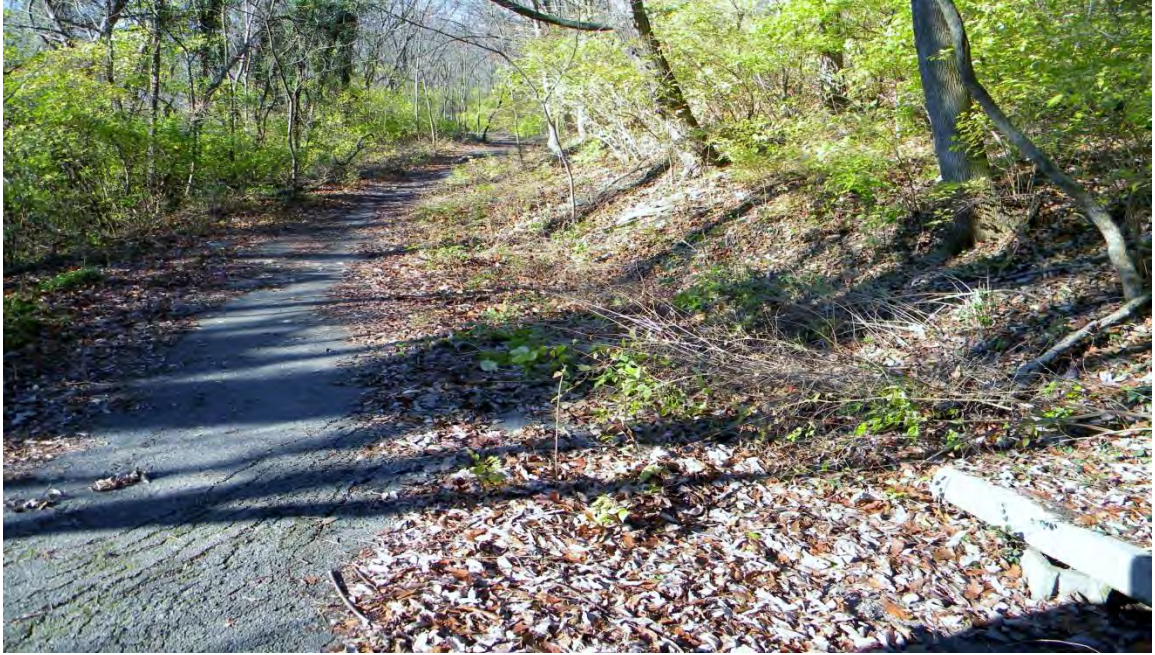
The series of failures that comprise the Delhi Pike landslide complex are caused by a combination of factors including the low strength properties of the soil, over steepening of slope during the construction of the Delhi Pike, poor drainage, and the addition of weight to the slope from the road and the houses.

Figure AV.9: Toe of one of the landslides at the Delhi Pike landslide complex site.

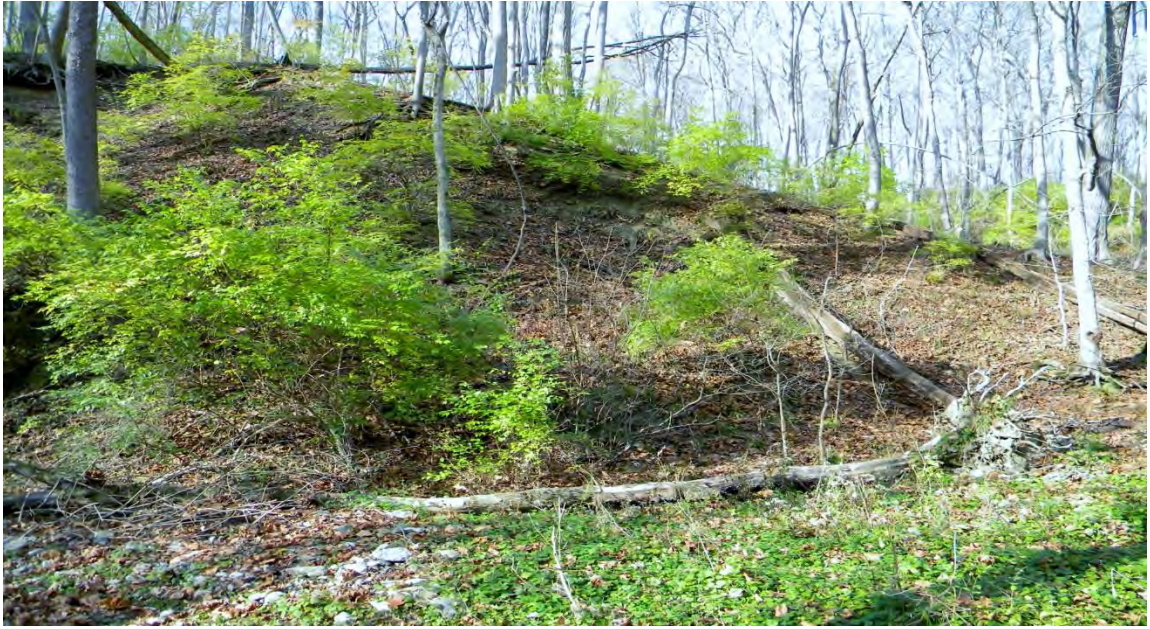
Appendix VI shows the use of LiDAR and aerial photographs in identifying landslides along the Nordyke Road. Figure AV.14 shows the damage to Nordyke Road as a result of landslide activity. The landslide studied is 12.8 m (42 ft) long, 11.9 m (39 ft) wide, and caused 3 m (10 ft) of displacement along the head scarp (Figure AV.15). Figure AV.16 shows the toe of the landslide.

The Nordyke Road landslide is the combined effect of low shear strength of the soil, the undercutting of the toe by the stream, and pore pressure buildup.

Figure AV.16: Toe of the Nordyke Road landslide.

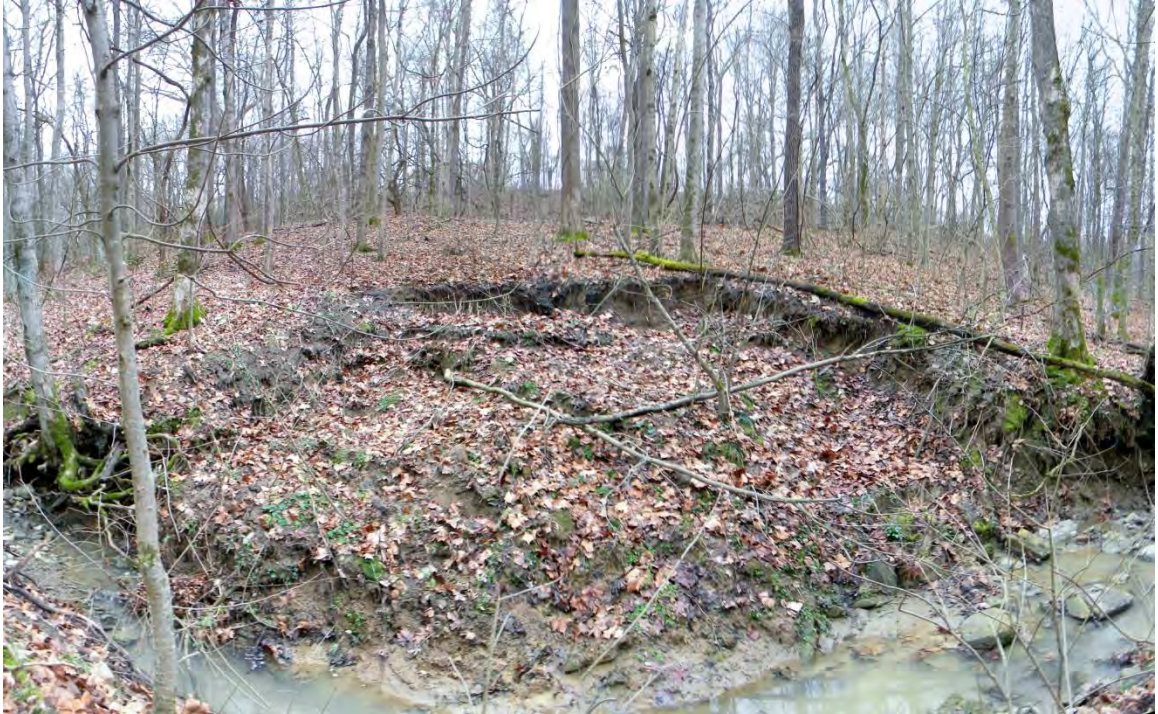
Similar to most of the other sites, the failure at the Old US 52 landslide site is the result of a combination of low shear strength of the soil, undercutting of the toe of the slope by a stream, and development of pore pressure during wet periods.

Figure AV.18: Scarp and toe the Old US52 landslide. Notice the small stream undercutting the toe.

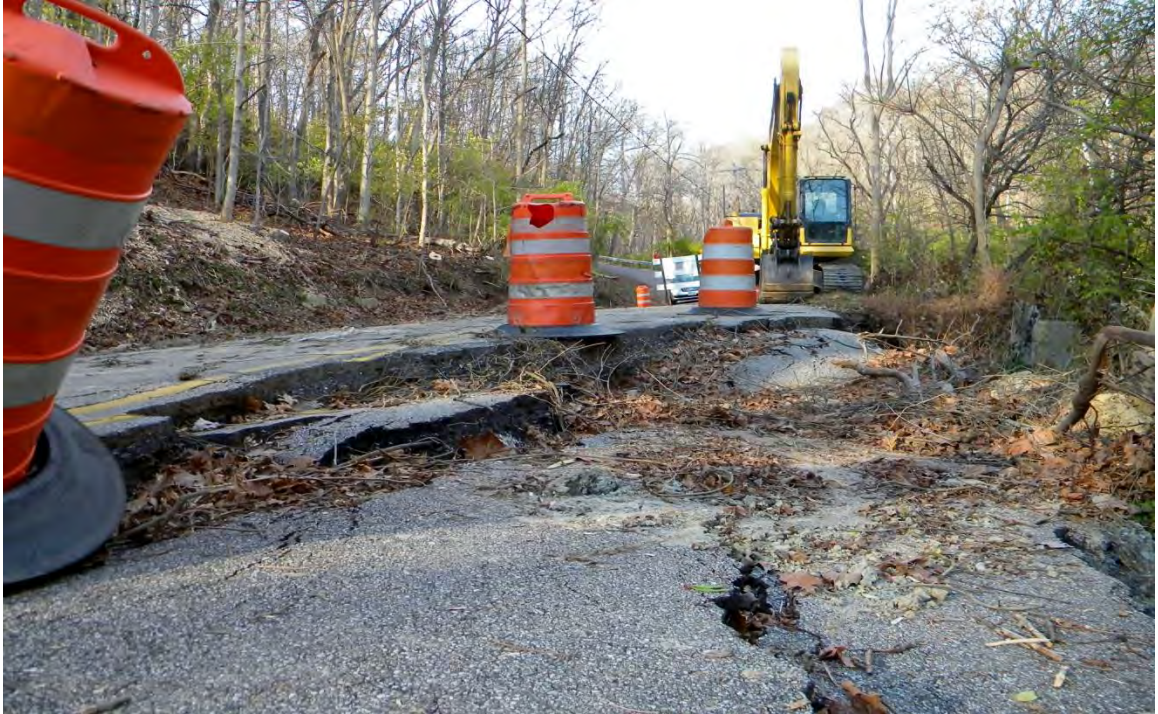
The failure along the Wagner Road is the result of a combination of toe undercutting by a stream, steepness of the slope, the added weight of the road to top of slope, and the low shear strength of the soil

Figure AV.20: Scarp and the associated displacement at the Wagner Road landslide site.

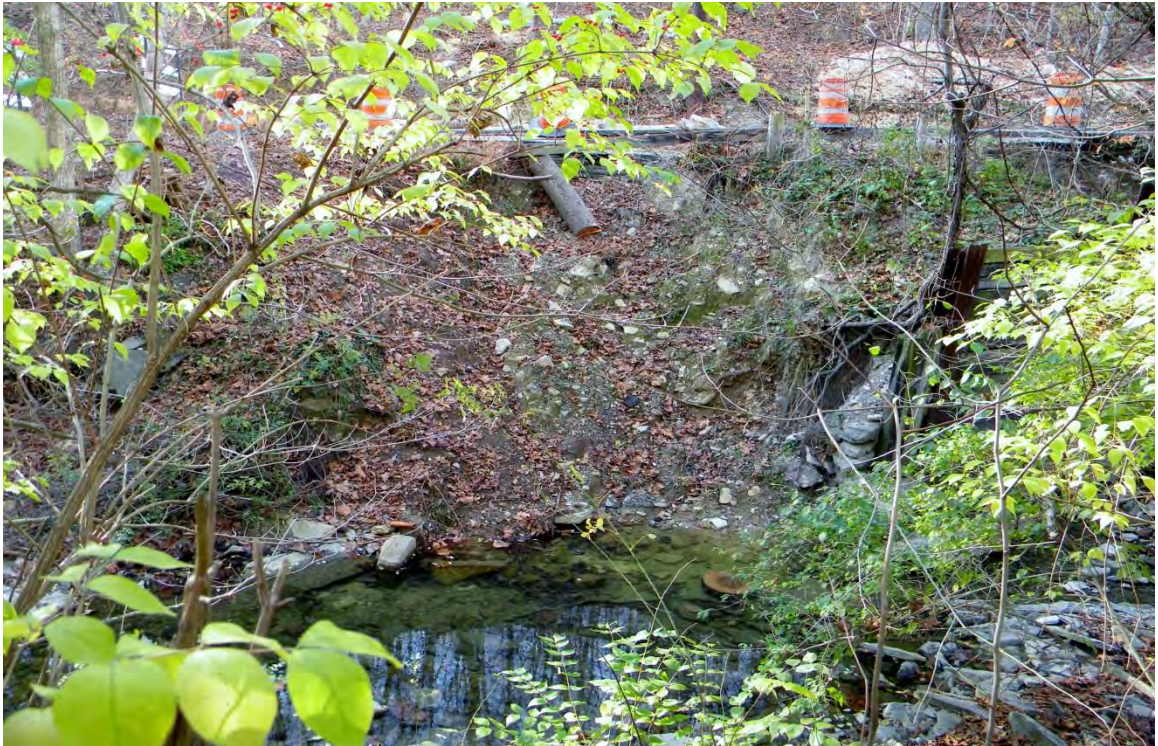
Figure AV.21: Toe at the Wagner Road landslide.

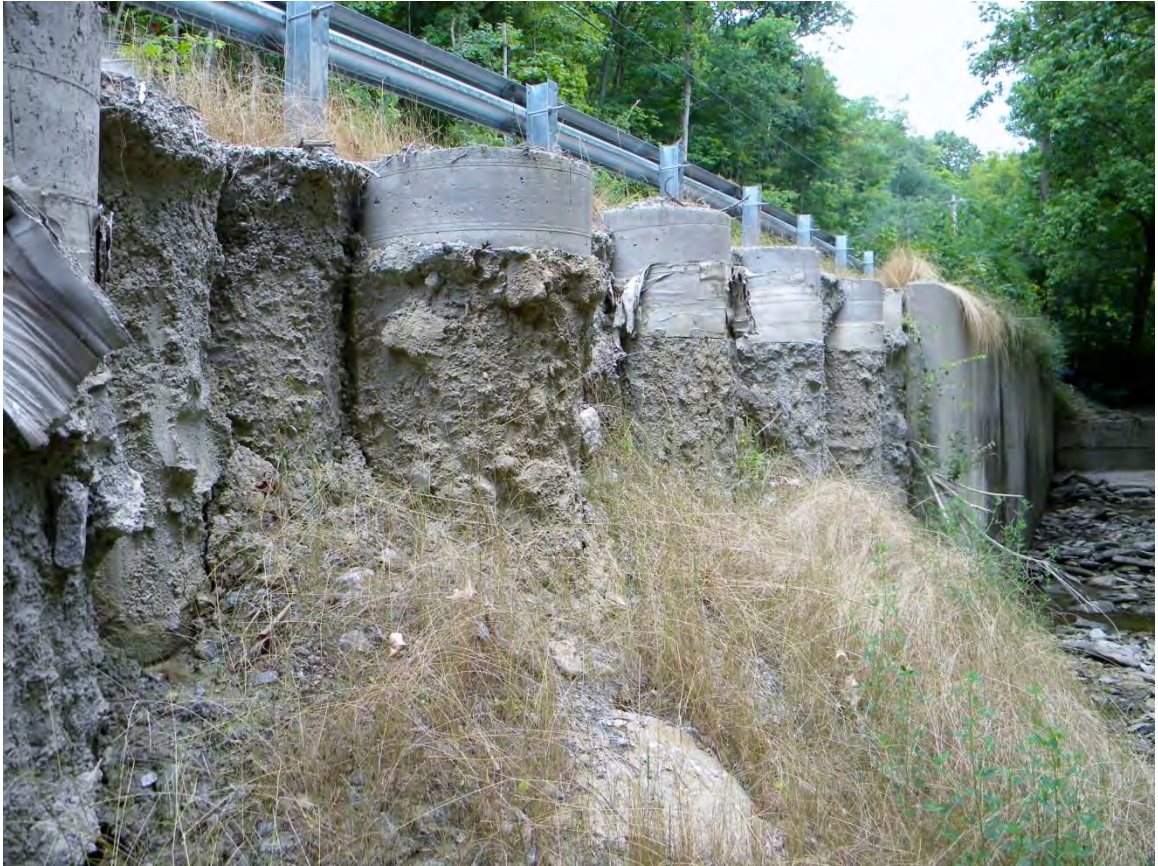
Figure AV.22: Remains of a retaining wall that had been constructed to stabilize Wagner Road.

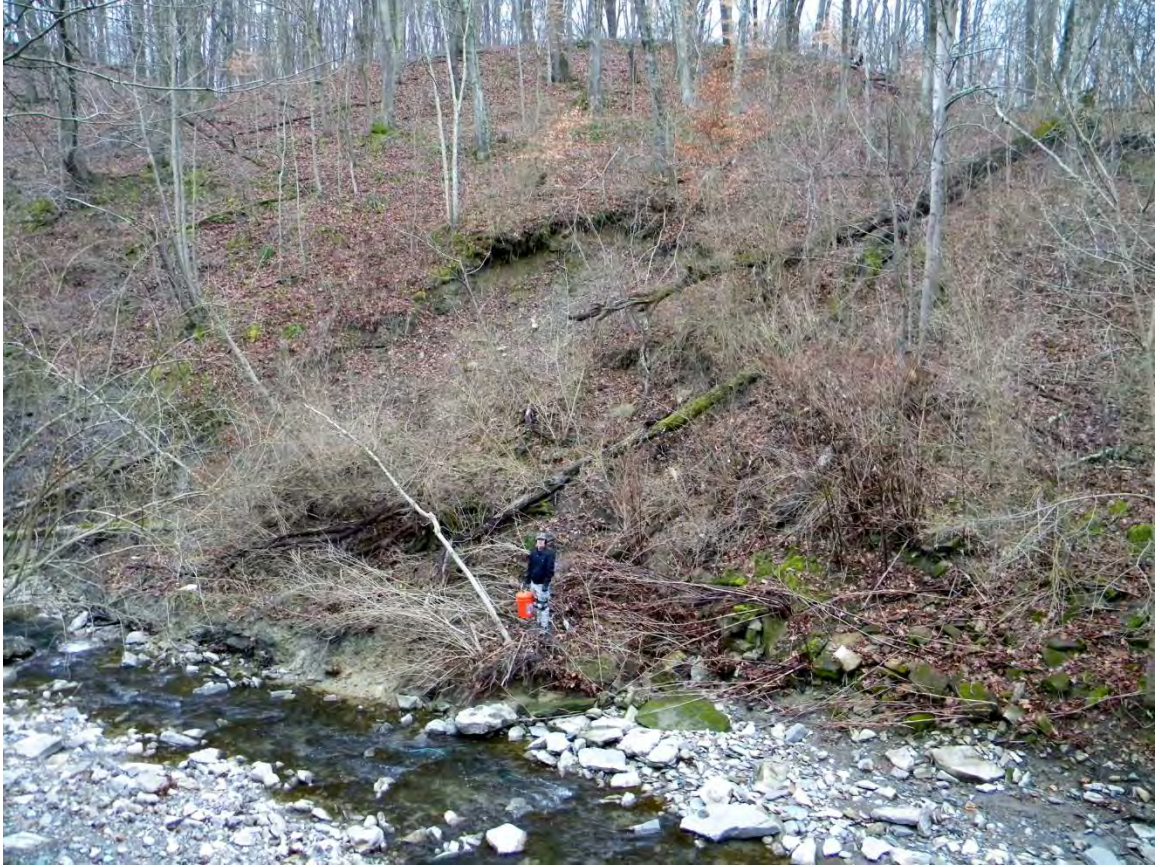
The Nine Mile Road landslide complex is located approximately 19 km (12 miles) east of downtown Cincinnati (Figure AV.23). Appendix VI includes the LiDAR derived maps and aerial photographs showing the Nine Mile Road landslide. The landslide is 15.3 m (50 ft) long and 6.1 m (20 ft) wide, with a 3.4 m (11 ft) of displacement along the main scarp. Thickness of the sliding mass was observed to be 1.5 m (5 ft). The toe of the landslide is located along the bank of a small stream (Figure AV.24).

The slide material at the 9 Mile Road landslide is similar to the other sites, a silty and clayey sand. The residual friction angle for the soil rock contact is  $14^{\circ}$  and a residual cohesion is 1.2 KPa (250 lb/ft<sup>2</sup>) (Table 4.5).

The low shear strength of the soil, undercutting of the toe of the slope by the stream, and pore pressure developing during wet periods, in combination, are the factors responsible for the Nine Mile Road landslide.

Figure AV.24: Scarp and toe of the 9 Mile Road landslide.

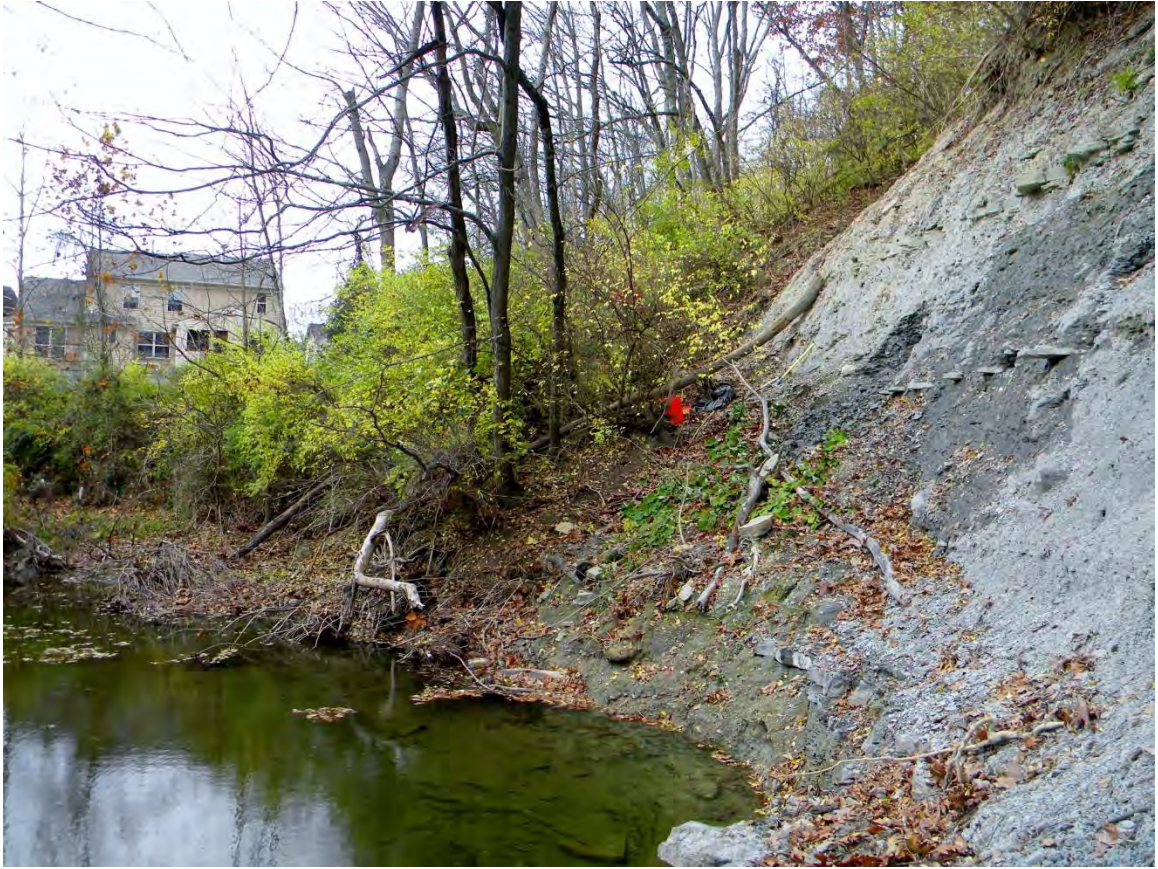
The Berkshire Road landslide complex is located approximately 13 km (8 miles) east of downtown Cincinnati (Figure AV.25). Appendix VI shows how the landslide appears on the slope map, hillshade map, terrain map, DEM map, topography map and aerial photos. The Berkshire Road landslide was also identified from field observations. The landslide is 9.1 m (30 ft) long, 3 m (10 ft) wide, and has a 4.6 m (15 ft) of displacement along the scarp face. The failure plane is inclined at 50° and the thickness of the sliding mass of soil is 1.5 m (5 ft). The toe of the landslide is located along the bank of a small stream (Figure AV.26).

The soil-rock contact at the Berkshire Road landslide has a residual friction angle of 8° and a residual cohesion of 1.3 KPa (271 lb/ft<sup>2</sup>) (Table 4.5).

The landslide at the Berkshire Road is the result of low shear strength of the soil, undercutting of the slope toe by stream water, and the steepness of the slope and the sliding surface.

Figure AV.26: Scarp and toe of the Berkshire Road landslide. Notice the accumulation of landslide debris in the toe area.

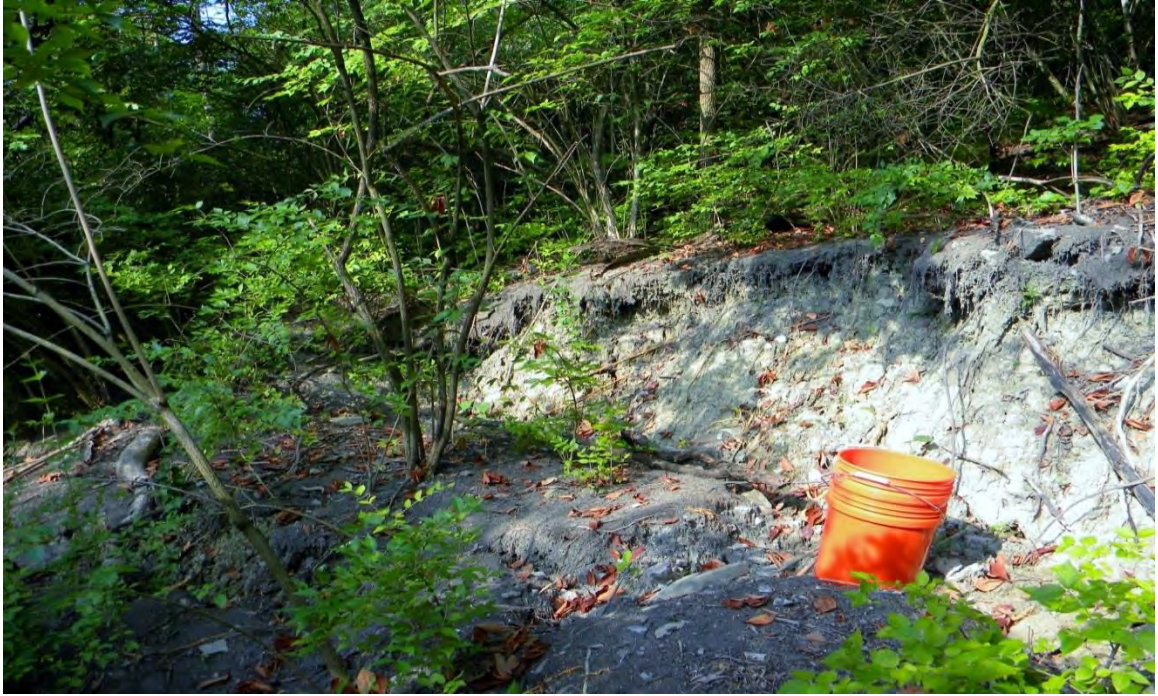
The residual friction angle for the soil-rock contact at the Columbia Parkway site is 15° and the residual cohesion is 0.7 KPa (142 lb/ft<sup>2</sup>) (Table 4.5).

The factors responsible for the Columbia Parkway landslide complex include the low shear strength of the soil, the constant removal of material at the toe of the slope by the City of Cincinnati, and development of pore pressure.

Figure AV.28: Head scarp of the Columbia Parkway landslide.

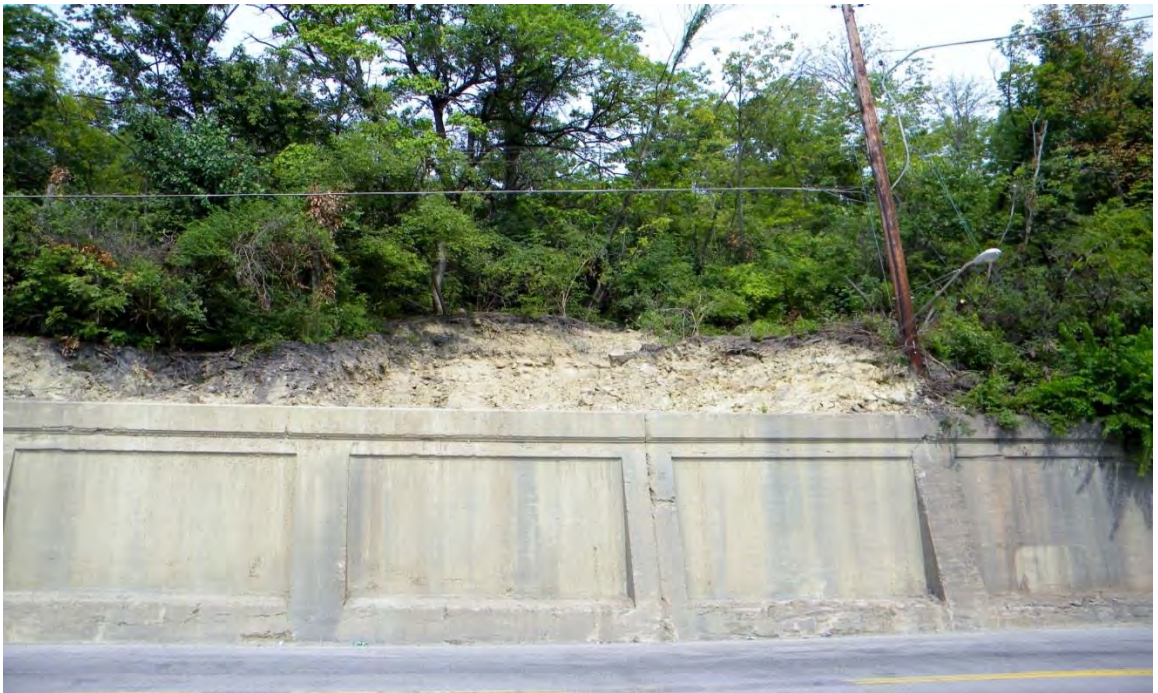
The Columbia Parkway landslide complex is located approximately 2.8 km (1.75 miles) east of downtown Cincinnati (Figure AV.27). The landslide complex was identified from field observations, landslide data from Hamilton County and from LiDAR derived maps (Appendix VI). The landslide is 58 m (190 ft) long, 12 m (40 ft) wide, and resulted in 0.75 m (2.5 ft) of displacement along the scarp face. The sliding soil mass is 2.1 m (7 ft) thick. The slope and the failure plane are parallel to each other and are inclined at an angle of 30°. The head scarp is located along the edge of Columbia Parkway (Figure AV.28) and the toe of the landslide is located at the top of a retaining wall along the Riverside Road (Figure AV.29).

Figure AV.29: Toe of the Columbia Parkway landslide, emerging on the top of the retaining wall.
